Manhole Inspection Summary

Manhole # S65M__012MH

Insp Date: **4/24/08 9:09 AM**

Location Address: **1113 Anglesea St.**

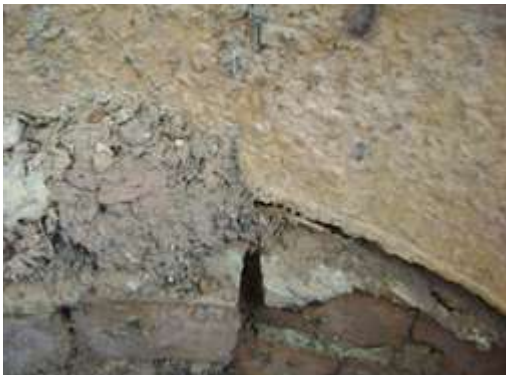
Defect 2

Condition: ☐ Sound ☐ Cracked ☐ Root Intrusion ☒ **Loose Brick** ☒ **Deteriorated**

cracked mortar at frame adjustment

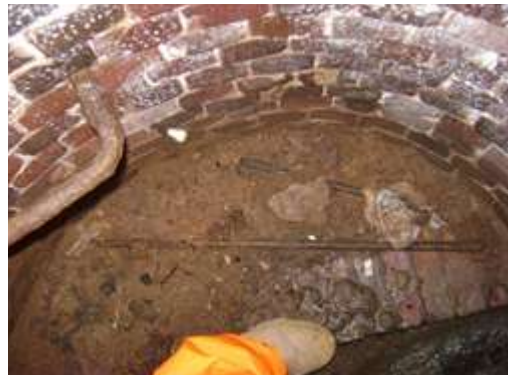
Defect 3

Condition: ☐ Sound ☐ Cracked ☐ Root Intrusion ☐ Deteriorated ☐ Leaks ☒ **Debris**

debris on bench

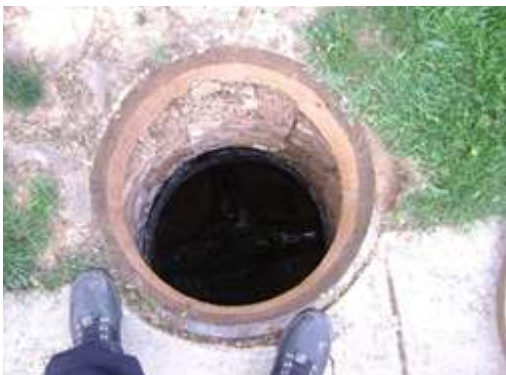
Defect 1

Offset: **3** (in.)

offset

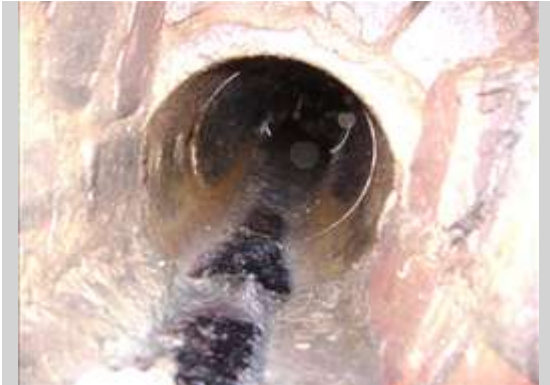
12 O'Clock Outflow

Pipe Height: **8.4** (in.) Rod and Bar (Angled)
Pipe Material: **Clay** ☐ Pipe Lined
Invert Depth: **9.33** (ft.) Flow Characteristics: **Slow**
Deposits: ☒ None ☐ Mud ☐ Sludge ☐ Debris ☐ Grease
Silt Depth: (in.) Deposits Extent:
Infiltration: **None** Pipe Seal Cond: **Sound**

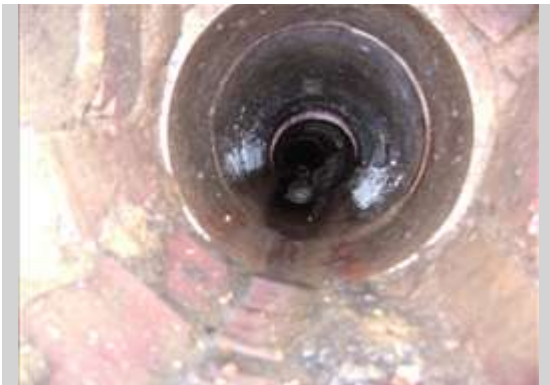
3 O'Clock Inflow

Pipe Height: **8.4** (in.) Rod and Bar (Angled)
Pipe Material: **Clay** ☐ Pipe Lined
Invert Depth: **9.00** (ft.) Flow Characteristics: **Slow**
Deposits: ☒ None ☐ Mud ☐ Sludge ☐ Debris ☐ Grease
Silt Depth: (in.) Deposits Extent:
Infiltration: **None** Pipe Seal Cond: **Sound**

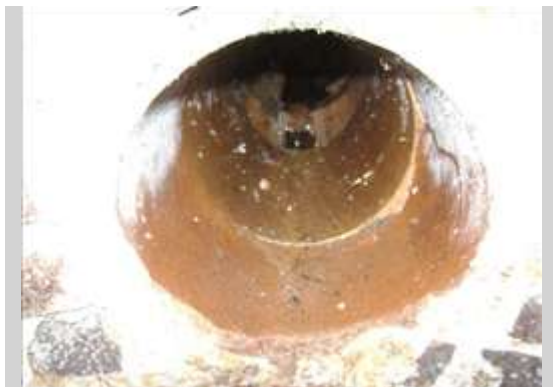
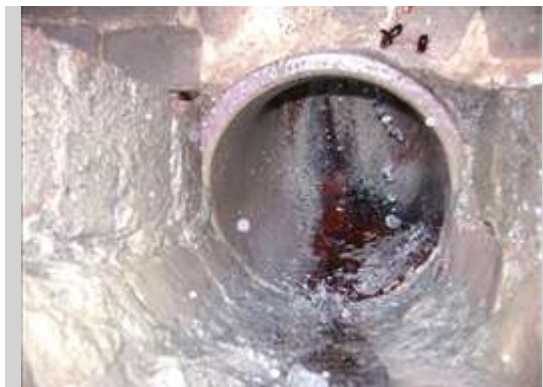
9 O'Clock Inflow

Pipe Height: **8.4** (in.) Rod and Bar (Angled)

Invert Depth: **7.92** (ft.) Flow Characteristics: **Slow**

Infiltration: **None** Pipe Seal Cond: **Sound**

Drop: Inside	Rod and Bar
Angled: Yes	Reading: 8.00 (ft.)
	Inv Depth: 9.00 (ft.)
Drop Condition: Open
